# **Navajo Abandoned Uranium Mine**

## **Site Screen Report**

### **Mesa IV, Mine No. 3 AUM Site**

#### **Navajo AUM Northern Region**

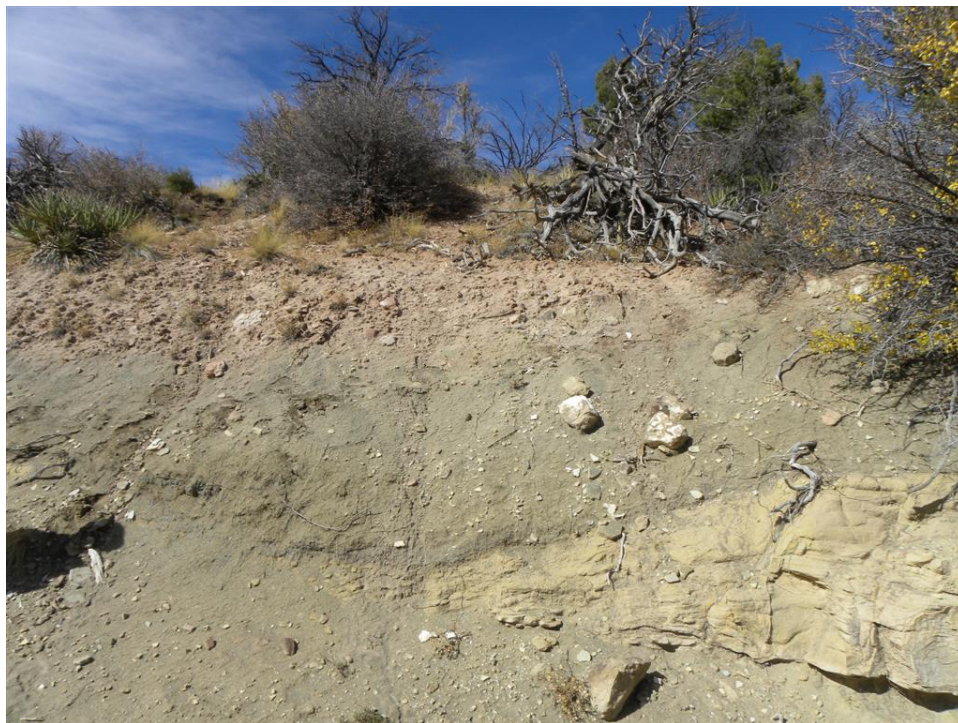
Waste debris extends through center strip of site, with a total estimated volume of 1,000 yd<sup>3</sup>

Photo 1. Waste pile

Unreclaimed waste pile

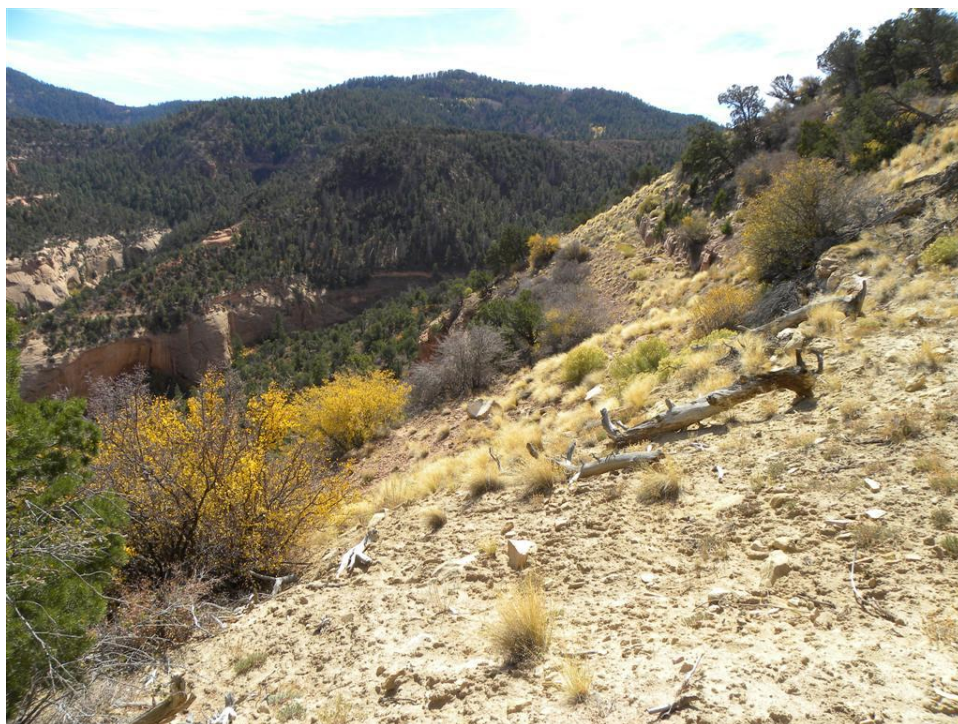
Photo 2. Waste debris and sloping area
